MOUNTAIN SPARK GAPS

**NPARC—The Radio Club for the
Watchung Mountain Area**

VOLUME 54 NO. 1 January 2019

My IC-718 Visits the ER Jim Stekas - K2UI

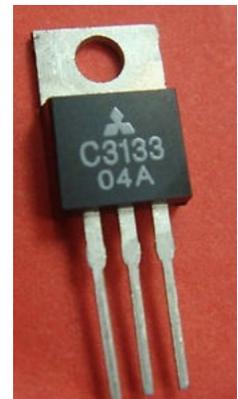
The IC-718 schematic provided the answer. The RF Power Amp (PA) board is connected directly to the input power connector and is always at 12V whenever external power is applied. The on/off state of the PA is controlled by the DC bias applied to the driver chips.² After removing the top cover of the rig I used my finger to determine what was getting hot. Sure enough, the driver transistors were burning hot³, but fortunately the final transistors were not even warm. A voltage check showed that one of the driver transistors had a base-to-collector short, making it act like a forward biased diode shorting the 12V supply to ground. I didn't measure how much current the rig drew in this condition but it was certainly less than 20A since the fuses in the power cord didn't blow. Estimating the heat generated to be roughly comparable to a 40W light bulb, my guess is the rig was drawing 3-5A.

The driver transistors are Mitsubishi 2SC3133, and replacing one (or both) would seem to be a very simple thing to do. But these 15W NPN transistors that are no longer manufactured, and none of the reputable US parts providers have any available. eBay, of course, is loaded with Chinese vendors advertising 2SC3133 parts for low prices, but reading the discussions on ham forums convinced me that these parts are pretty much guaranteed to be counterfeits that don't work.

In one posting a ham scoffed at all the hand wringing over the scarcity of genuine 2SC3133 parts when a perfect substitute, the NTE236, was readily available. Sure enough, a quick glance at the NTE236 specs showed it to be an exact match to the 2SC3133. The price was right so I ordered four NTE236 transistors from a true blue US supply house.

When they arrived I tested them with the tester I built as part of our club project, and good thing that I did. The tester showed that although the electrical specs were the same, the pinout pattern of the NTE236 swapped positions of the emitter and collector leads. Even worse, the NTE236 fin was connected the collector, not the emitter as in the 2SC3133. There was no way the the NTE236 was going to work in the IC-718. For \$30 I acquired four transistors I will never use and a greater respect for the hand wringers.

In the past, I have had good luck with the ICOM parts department, so I figured I'd give them a call. They had the real 2SC3133 in stock and I ordered a pair for \$50 shipped. Not cheap, but paying \$25 for a part that works is a bargain compared to \$10 for a part that doesn't. Four days later I replaced both drivers, tweaked the bias, and verified that the IC-718 was fit for another Field Day.
