# **MOUNTAIN SPARK GAPS**

**VOLUME 53 NO. 9 September 2020**

## Vintage Linear PSU Repair

Jim Stekas - K2UI

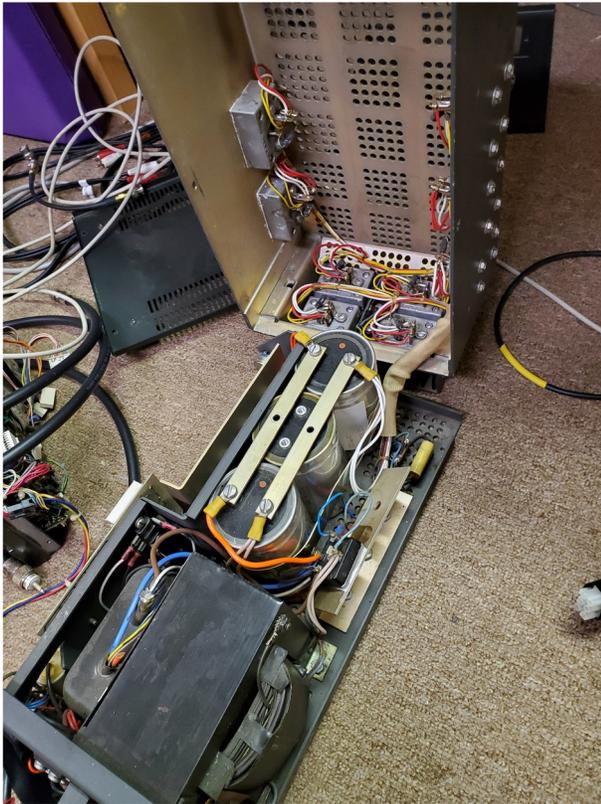
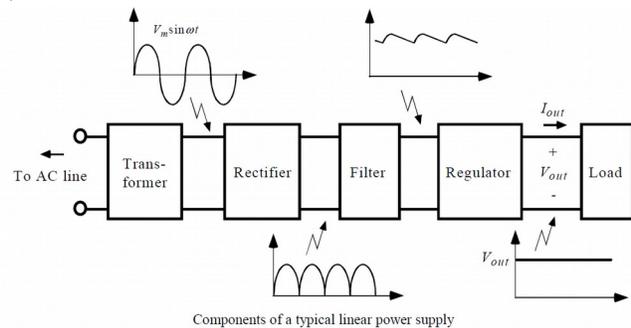
Upon inspection, the internal circuitry seemed to share the architecture of linear PSUs of the same vintage, such as the ICOM PS-15, Astron RS-35A, etc.

A big 5:1 power **transformer** (lower left) steps down the line voltage which feeds a full wave **rectifier** (little black square middle right). Three electrolytic capacitors in parallel **filter** the rectifier output producing a clean 24V DC. The voltage **regulator** (not visible) controls 8 pass transistors (mounted inside the cover) to drop the 24V to 13.8V.

The PSU started life with 3 capacitors of unknown value. A load that draws 25A from a 13.8v supply looks like a  $0.5\Omega$  load. To effectively shunt AC around that load we want a capacitor that has a reactance less than 1/10th of that, which is

–  $j \cdot 0.05\Omega$  at 120Hz, or about 26,000 $\mu\text{F}$ . The Astron RS-35A filter stage uses 50,000 $\mu\text{F}$  so my goal was to get at least that much capacitance into my PSU filter.

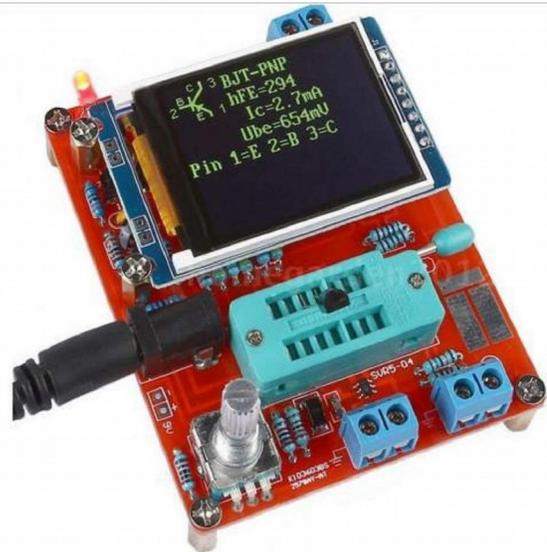
Thanks to Jon Pawlik, AE2JP, many of us built the GM328 all purpose tester kit as part of an NPARC project. Its spec sheet claims that it will measure capacitance from 25pF to 40,000 $\mu\text{F}$ . It also measures effective series resistance (ESR) which gives an indication of resistive loss. For large capacitors, accuracy isn't an issue. Typical parts have tolerances of -10/+25%. In this application the goal is to provide as much capacitance as possible. The GM328 confirmed what I suspected, all the caps in my PSU were bad.

I installed both replacement caps and left the disconnected cap right where it had been. With the bad caps replaced, the PSU filter totaled 70,000 $\mu\text{F}$  and whatever AC hum remains, it is undetectable on the scope<sup>1</sup>.
